# CITY OF SANTA CLARA GEORGE F. HAINES INTERNATIONAL SWIM CENTER VISUAL OBSERVATION ASSESSMENTS REPORT

## VISUAL OBSERVATION ASSESSMENTS REPORT

**PREPARED FOR**  
CITY OF SANTA CLARA

**PREPARED BY**  
LPA, Inc.  
& Aquatic Design Group, Inc.  
& Simpson Gumpertz & Heger

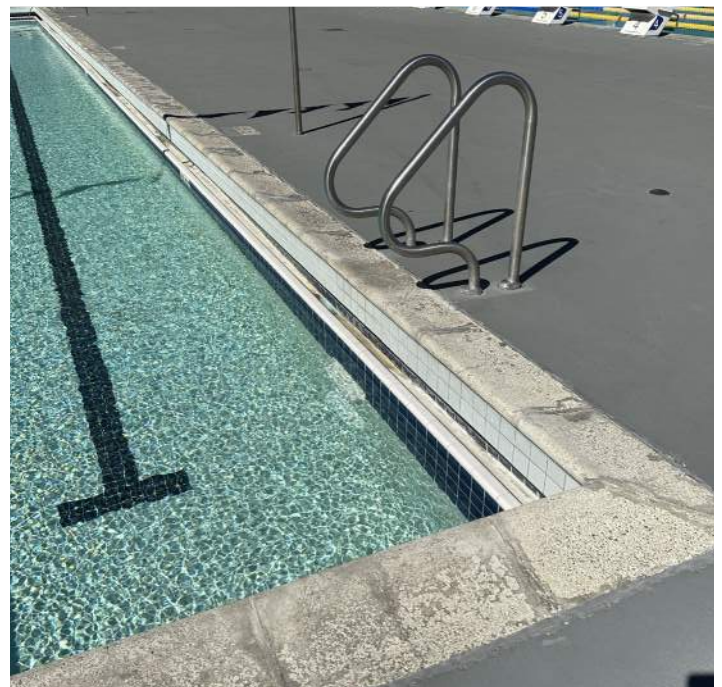
Image 12: Instructional Pool Coping Stones

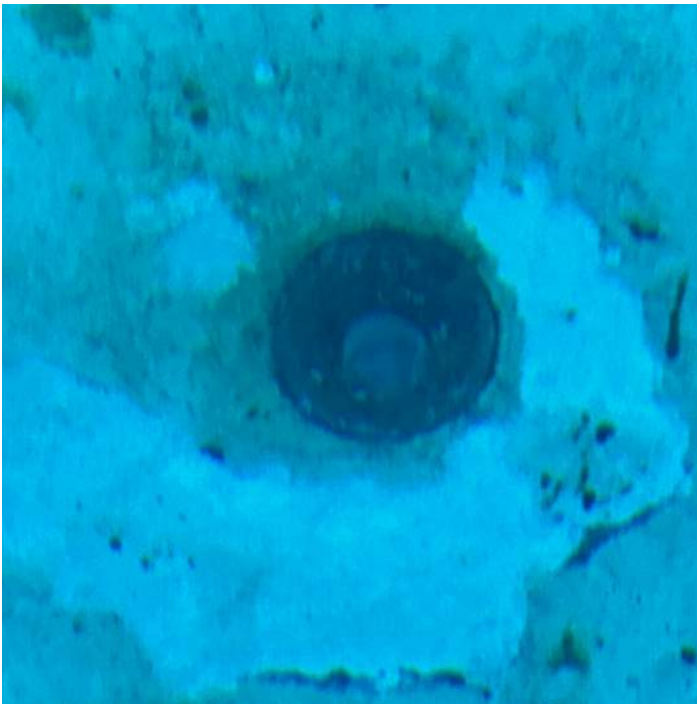
Image 14: Diving Pool Floor Inlet Without Flow Insert

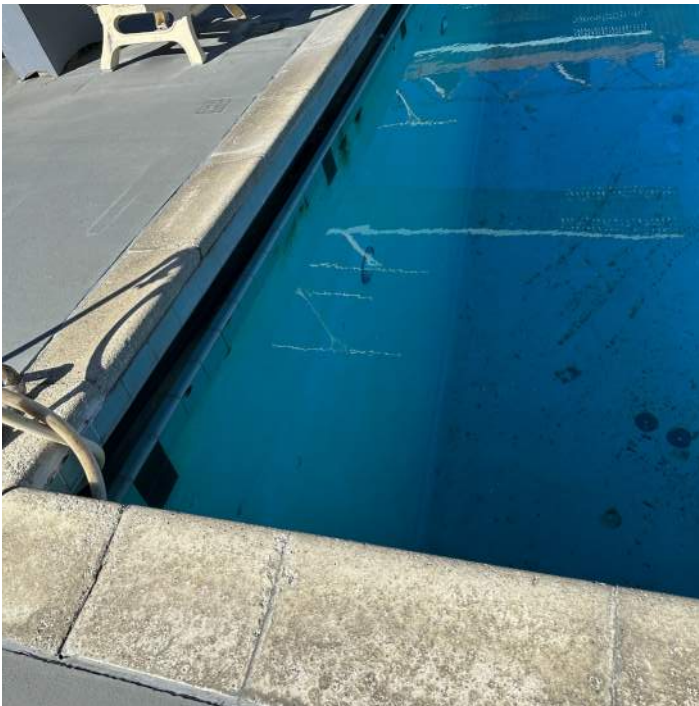
Image 17: Diving Pool Coping Stones

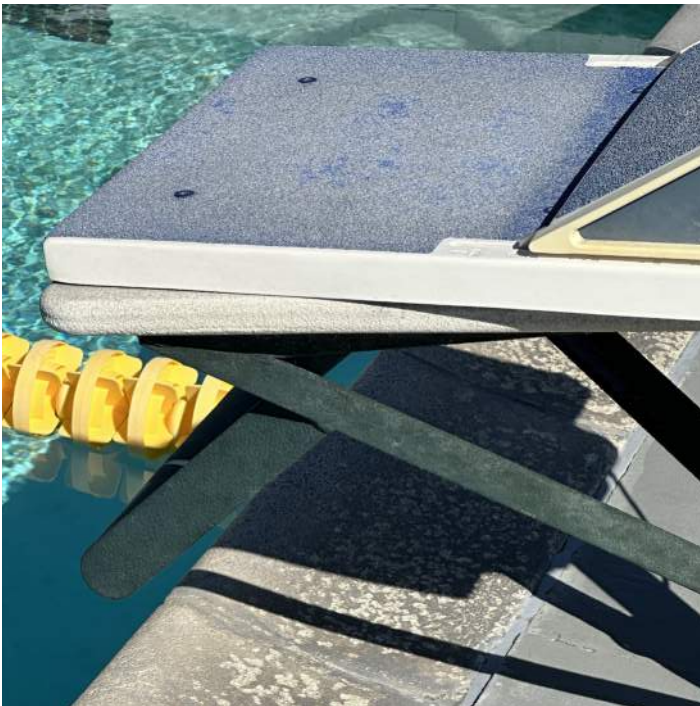
Image 23: Aging Anti-Slip Finish on Racing Platforms

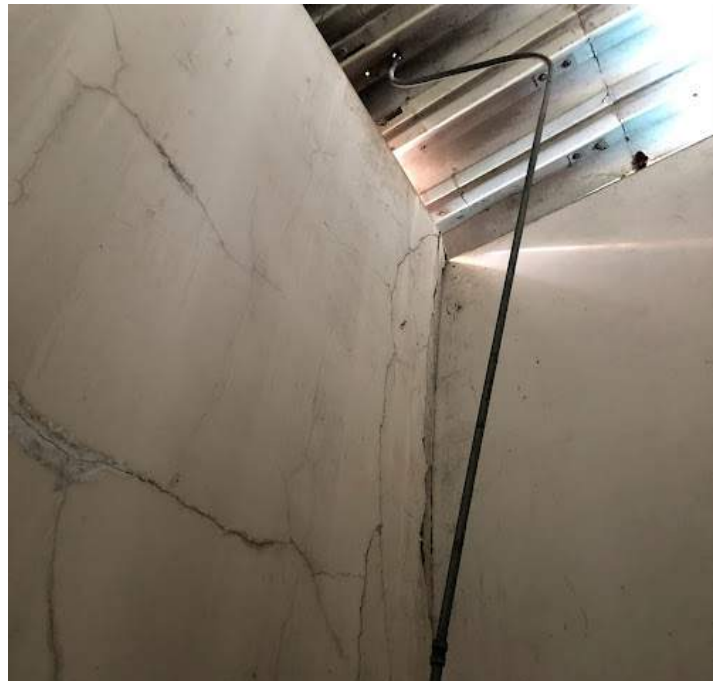
- c. The canopy tower access structure that houses the access ladder to the top of roof deck is badly damaged. Severe water damage and drywall cracks are observed on all walls of the structure. Rusting of metal stud bottom tracks are observed. Metal stud walls enclosed by the gypsum wall board are anticipated to be badly rusted as well. This is a stand-alone structure without connection to the roof structure. The gravity and lateral load resisting system is primarily metal studs and drywall. With the severity of the damage observed, most of the lateral load resisting system have been compromised, it is unsafe to be inside the structure.

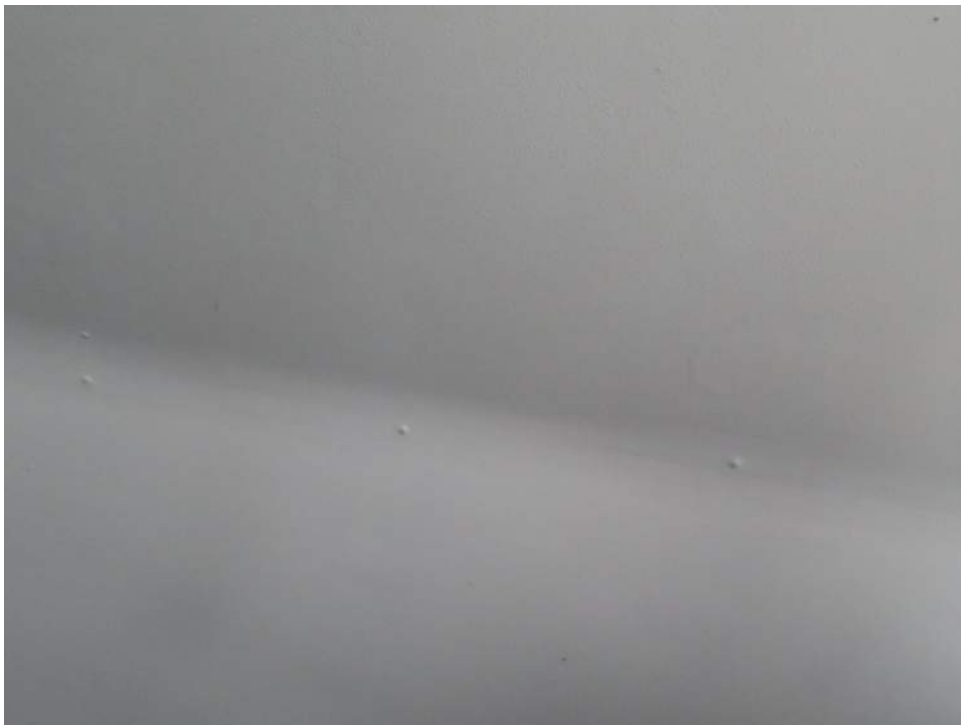
**Photo 10**

Missing shingles on the roof hips align with the ceiling crack, nail pops, and bubbling in the gypsum wallboard.
