# CITY OF SANTA CLARA GEORGE F. HAINES INTERNATIONAL SWIM CENTER VISUAL OBSERVATION ASSESSMENTS REPORT

## VISUAL OBSERVATION ASSESSMENTS REPORT

**PREPARED FOR**  
CITY OF SANTA CLARA

**PREPARED BY**  
LPA, Inc.  
& Aquatic Design Group, Inc.  
& Simpson Gumpertz & Heger

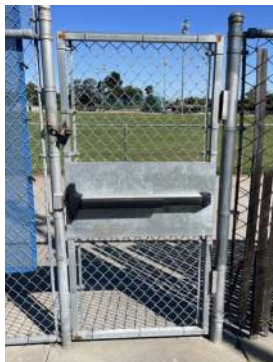
EXISTING CHAINED EXIT

Based on how the facility currently operates, the main exit path is not in compliance with California Building Code for safe emergency egress. All users are required to enter and exit through a single entry within the main entry building. In an emergency, the main path of egress divides into two directions, only to funnel the two paths back into the buildings in one main exit path. This is not

compliant with code and a life safety hazard during an emergency.

Our findings show that it is needed to have additional exit lengths to total 87 feet and a minimum of four exits with panic hardware, per the 2022 California Building Code.

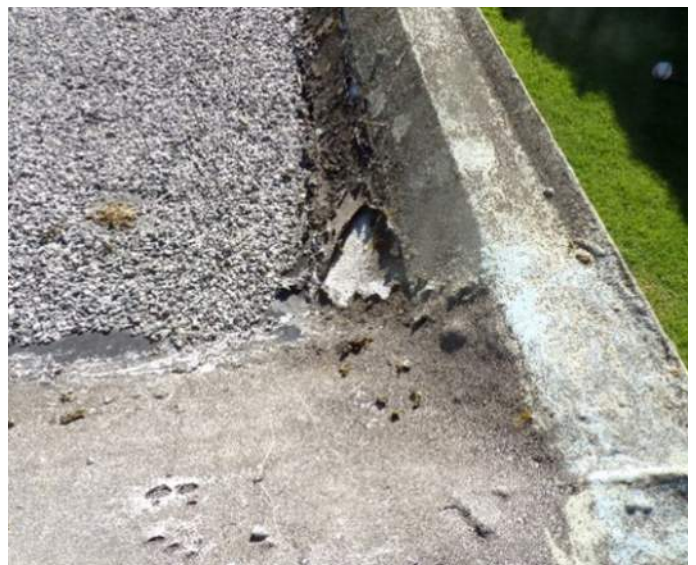
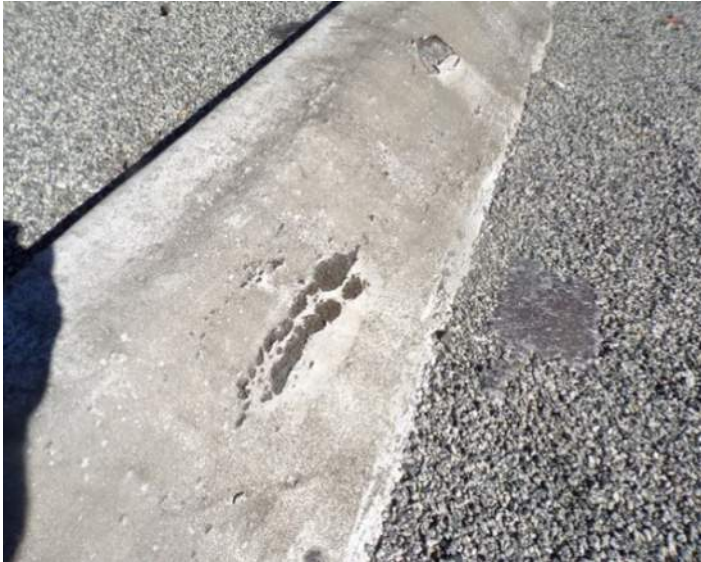
- Approximately 40% of the built-up roof exhibits signs of distress and inadequate drainage, such as bar spots and cracked plies and asphalt.
- Debris (e.g., dislodged asphalt shingles, swimming attire, wood crates) exists on the roof (Appendix A, Photo 3).

- Wide parapet caps and rooftop mechanical chutes exhibited oil canning (i.e., visible, wavy distortion that affects cold-rolled metal products) (Appendix A, Photo 4).

The roofs at this Facility exhibit significant distress and deterioration. Further, the roofs are beyond their useful service life, particularly the low-slope, built-up roofs. Lastly, the layout and configuration of the low-slope roofs near openings and along the perimeter fail to comply with current safety codes and standards. Given the current condition and configuration of the roofs and roof accessories, we recommend wholesale removal and replacement with code-compliant roofs.

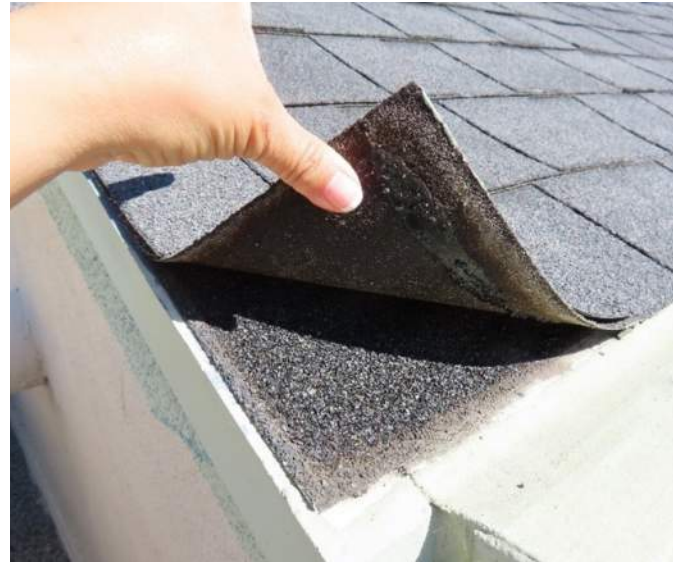
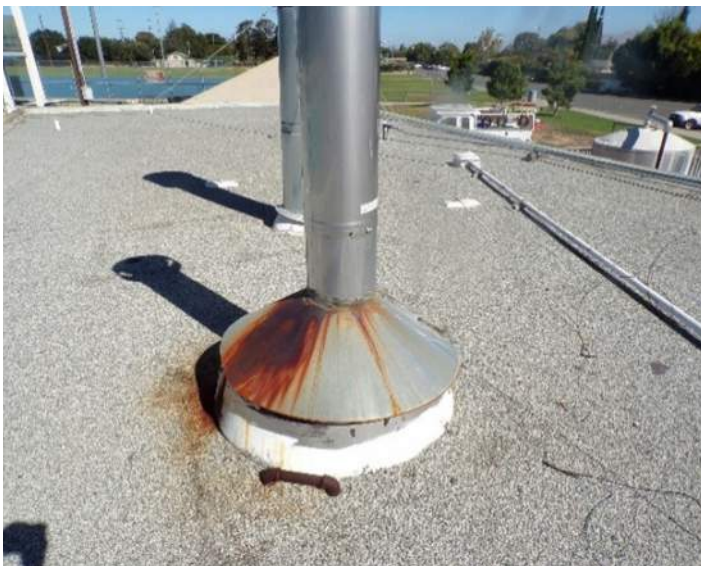
- Approximately 60-70% of the composite, asphalt shingles at the saw-tooth roofs are inadequately adhered and could be lifted with relative ease. These poorly adhered shingles occur along the rake edge and within the field of the roof (Appendix A, Photos 5 & 6). Algae growth exists on the downslope edges of asphalt shingles (Appendix A, Photos 7 & 8).

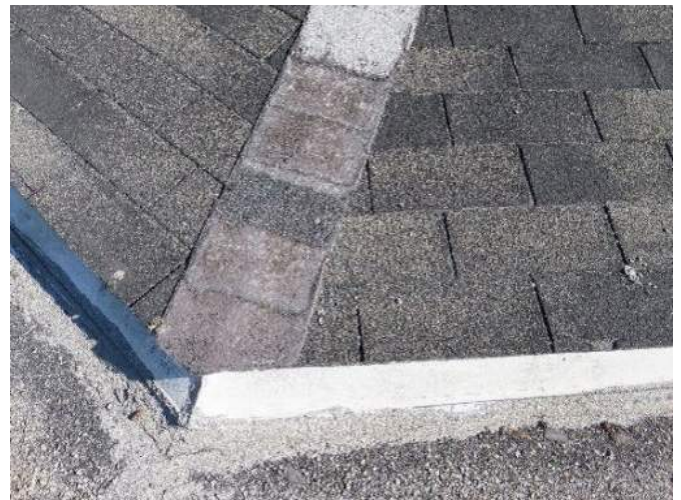
- Approximately 70% of the asphalt shingles we checked at the octagonal, steep slope roof are dislodged or inadequately adhered. Most of the asphalt shingles on the hips are dislodged, missing, or have significant granular and
- The missing shingles on the hips align with the ceiling cracks, nail pops, and bubbling in the gypsum wallboard below (Appendix A, Photos 9 & 10).

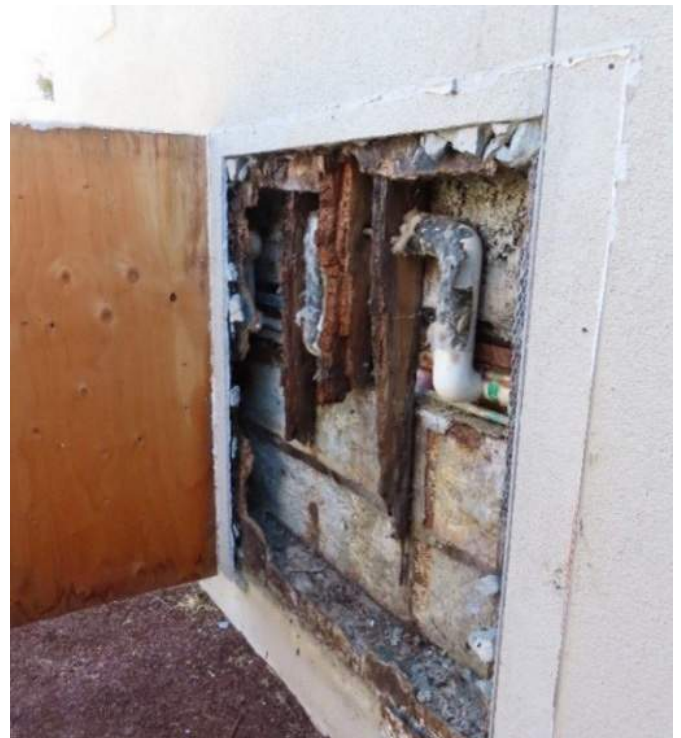
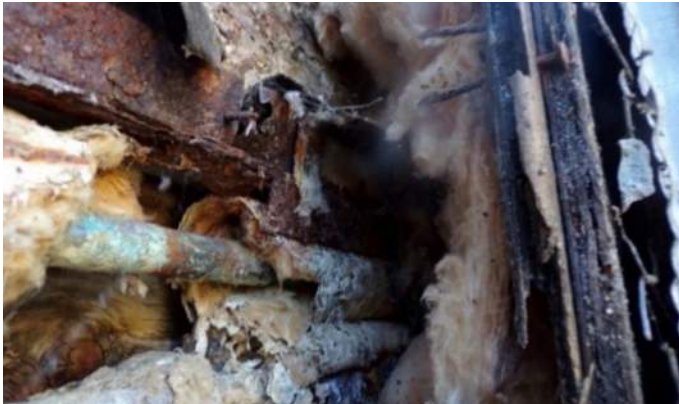
- Significant and extensive decay and cross-sectional loss of the load-bearing wood studs.
- Extensive and significant decay of the exterior plywood sheathing behind the stucco assembly.
- Extensive corrosion and significant cross-sectional loss of metal components (i.e., copper pipes, metal tracks, nails, and metal lath).

- Missing building paper layers, which means there is no code-required, water-resistive barrier.
- Stucco cracks, spalls, and patches at all stucco-clad buildings.
- Water stains on stucco soffits with no soffit drip screed or other provision to weep.
- The aluminum windows and storefronts at Building A show signs of wear and tear, including deteriorated glazing seals and gaskets (Appendix A, Photos 17 & 18).
- Significant wood decay at exterior window trim (Appendix A, Photo 19)
- Extensive corrosion and deterioration at exterior hollow metal doors (Appendix A, Photo 20).

While stucco can provide as a serviceable cladding for over 50 years if design and maintained properly, the stucco walls at the Facility are exhibiting signs of water damage, such as cracking, spalling, staining, and mildew growth. We also did not observe any water-resistive barrier in the destructive opening through the stucco assembly. If the other stucco-clad walls at Building A have no water-resistive barrier, then all stucco-clad walls will need to be removed and rebuilt.

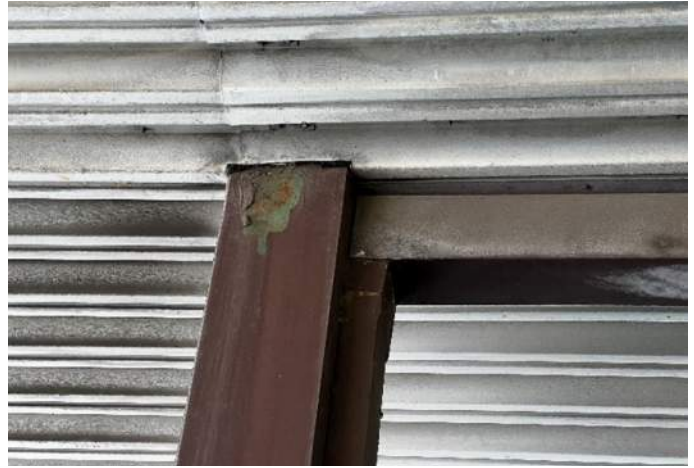
- The eight columns supporting the canopy truss structure appear to be in good condition. The base coating of these columns is well adhered to the steel substrate, but the top coating is delaminating in discrete, localized areas. We did not observe any significant corrosion of the steel substrate, even at the low point where the columns intersect the concrete bleacher steps.

- UT measurements taken at the base of the eight columns (1 in. to 6 ft above the bleacher steps) show no significant variations in the steel thickness with height or between the columns. Refer to these UT measurements in Table 1. These consistent thickness measurements indicate little to no corrosion of the inner surface of the tubular columns.

The canopy support columns and canopy support truss structure appear to be in good condition. We recommend stripping the current coating and recoating them with a two-part epoxy coating. We did not detect lead in our coating analysis at these locations. The localized corrosion on the canopy panels is likely due to original local coating defects rather than debris accumulation and ponding water. These local areas could be cut out and replaced, with the remaining panels stripped and recoated. However, it might be more cost-effective to replace these panels. The canopy gutters are corroded past their useful life and should be replaced with a non-metallic gutter system. The canopy tower appears to be in good condition and no work is required on the stairs or railings. The corroded door and frames should be replaced with components that are designed for external exposure. The solar heating pipe risers should be removed, and the local deformation of the roof panels repaired.

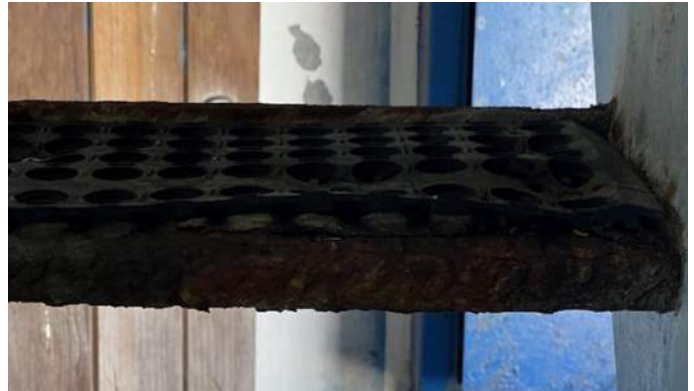
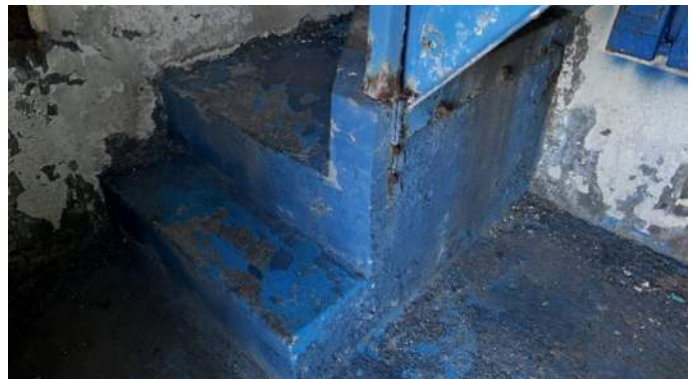
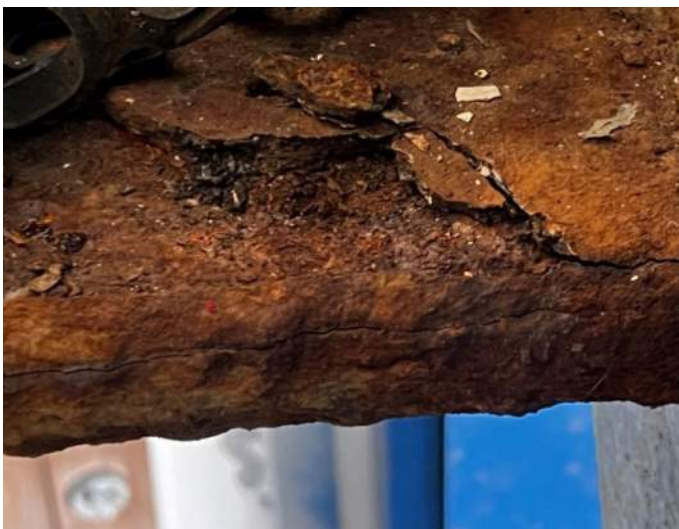
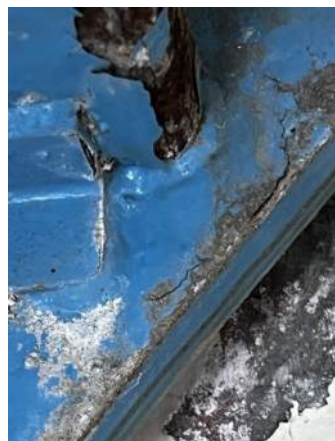
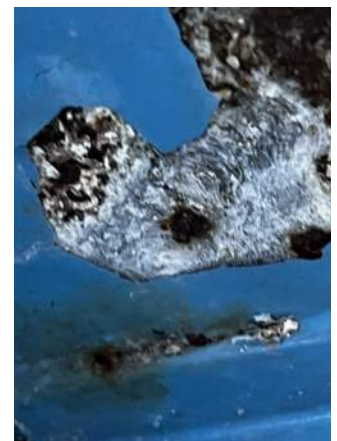
- The dive tower staircase is in poor condition with extensive corrosion, particularly on flat surfaces and crevices. Welds are also corroded with the lower section more heavily corroded than the upper section.
- Many of the original coatings have completely delaminated, resulting in a significant accumulation of corrosion products.
- Areas of white corrosion products exist underneath delaminated sections of coating.

The dive tower staircase is heavily corroded and should be replaced. The white corrosion products that we observed suggest that underneath the coating, the metal substrate is galvanized, which is not a suitable coating for structures such as these which are frequently wet and enclosed in a humid environment. We recommend removing and replacing it with a code-compliant structure fabricated from a corrosion-resistant alloy, such as 316 stainless steel.

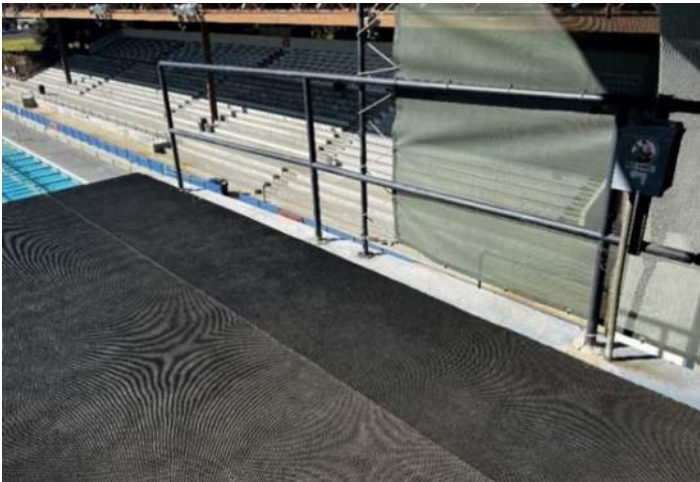
- The railings along the edge of the dive tower platforms appear to be in good condition with intact coatings and no visible corrosion. However, we observed coating loss and corrosion at the base of the railings at the plane of the pool deck.
- We were unable to conduct UT measurements at these locations, but using a knife to remove corrosion products we measured corrosion loss of at least 1/8 in.

The railings on the dive tower platforms are corroded at their base, which has likely affected their structural integrity. The railings should also be replaced with a code-compliant structure fabricated from a corrosion-resistant alloy.

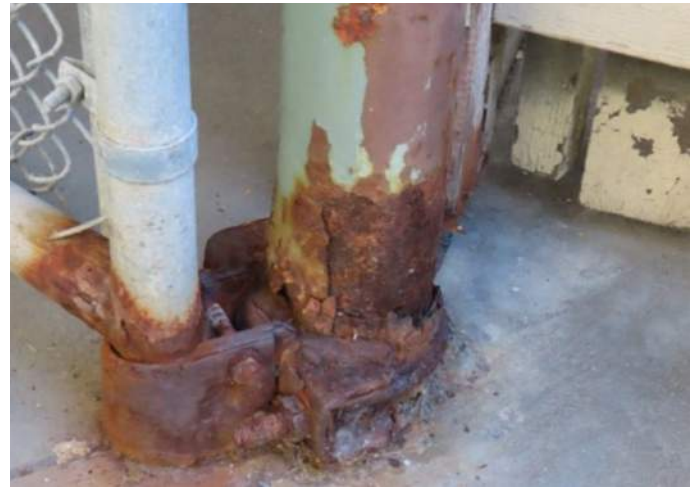
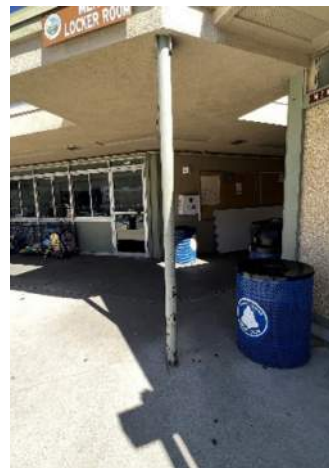
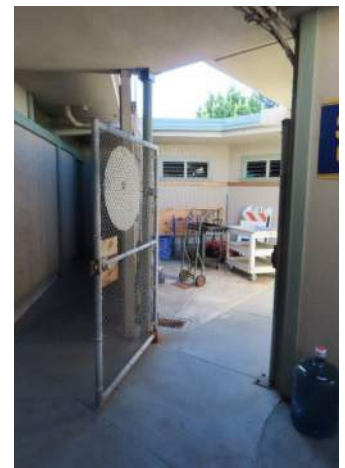
- The posts, particularly at deck level, exhibit coating failure and localized corrosion of up to 50%.

The Building A canopy supporting poles have corroded at several locations, especially at their base, with thickness loss of up to 50%. We recommend that these poles be replaced with carbon steel posts coated with a 2-part epoxy system.

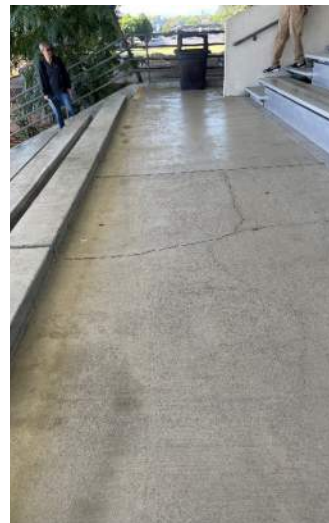
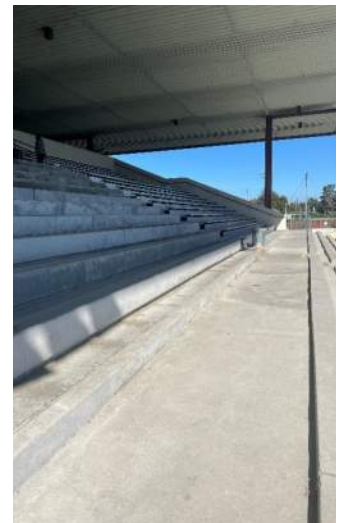
- The concrete slab and steps appear in fair condition, with moderate settlement cracking observed.

The construction of the stadium bleachers appears to be in fair condition structurally. However, we note that architecturally, there may be some concerns. The settlement of the concrete stair elements may constitute a trip hazard. If the hazard is deemed significant, the concrete steps and slabs should be removed, soil compacted, and replaced in kind.

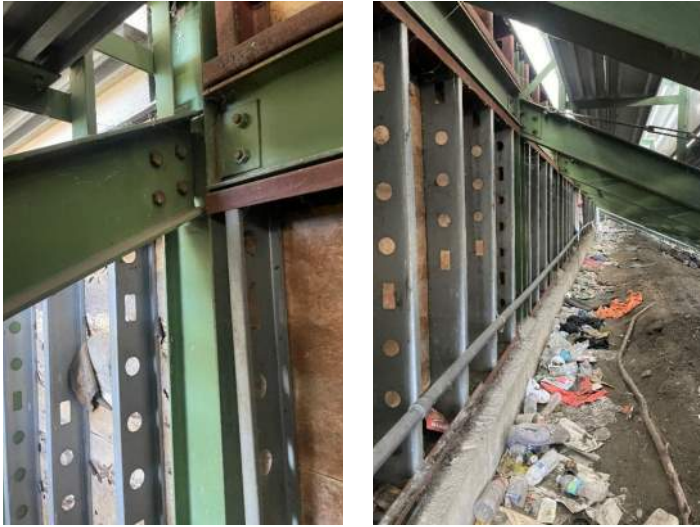
- The steel beam stringers, posts, and seat support elements are painted and appear to be in sound condition with no visible signs of corrosion.

Annual visual observations of the structural steel elements should be performed to inspect for signs of corrosion or deterioration.

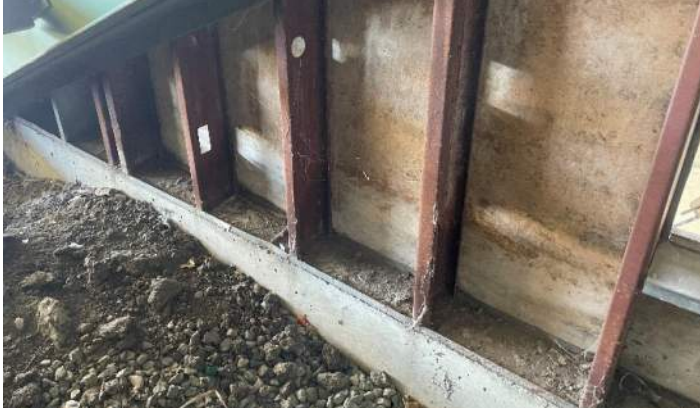
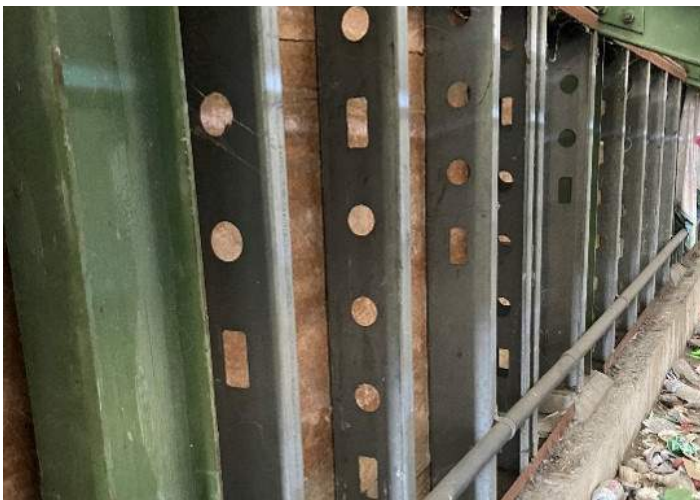
- Many of the studs for the perimeter walls have been replaced with newer galvanized studs, however top and bottom tracks appear to be original and exhibit signs of corrosion. These light gauge stud and track elements are not structural elements.

Additionally, given the exterior condition of the stadium, the non-galvanized light gauge stud wall framing should be replaced with galvanized construction.

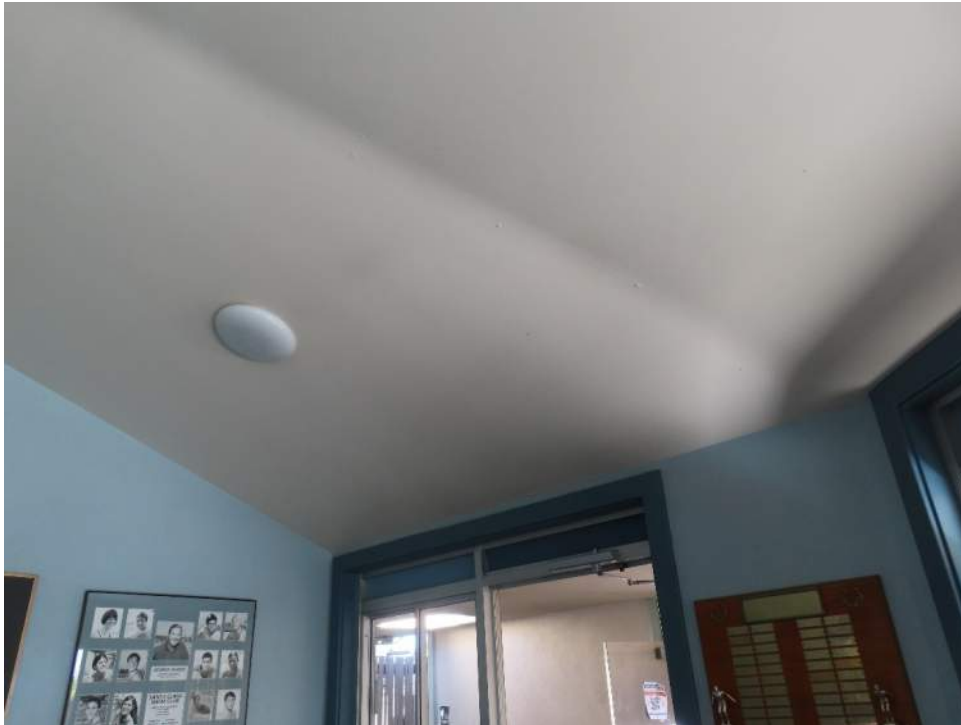
**Photo 9**

Missing shingles on the roof hips align with the ceiling crack, nail pops, and bubbling in the gypsum wallboard.
